SAKURA
Filtration Product

DO NOT INSTALL DENTED FILTERS!

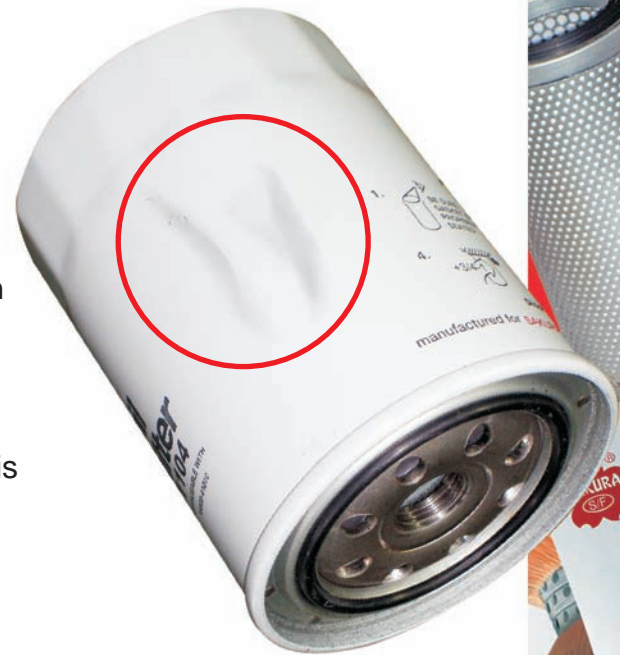
Filter manufacturer occasionally receives used filters involved in warranty investigations due to a crack in a spin on filter. In many cases the crack is located within or near a dent of the can. This evidence predominantly indicates that the dent caused the crack and that the failure was not within the control of the filter manufacturer. Once the steel gets dented, a concentration of stress in the material created, making the can more susceptible to fatigue.

Filter can is designed with low carbon steel to resist fatigue and is formed so the pulses and vibrations in the system are equalized over the surface area of the can. A dent provides an area of stress concentration from pressure pulses, vibrations and can greatly shorten the fatigue life of the can.

To avoid dents in the can, please install spin on filter carefully. Check by visual the spin on filter that will be installed, if there is any defect dented, replace it with the other one. Sometimes it takes a wrench to install the filter, choose the wrench that fits with the design of the filter can. Do not use wrench that could potentially create dent on filter can.
